**ADDENDUM NO. 1**

**CITY OF PENDLETON**  
**Connector Road Waterlines Project**  
**Issued: November 13, 2023**

## **Geotechnical Engineering Evaluation**

Connector Road Water Line  
City of Pendleton Water and Sewer System  
Upgrades

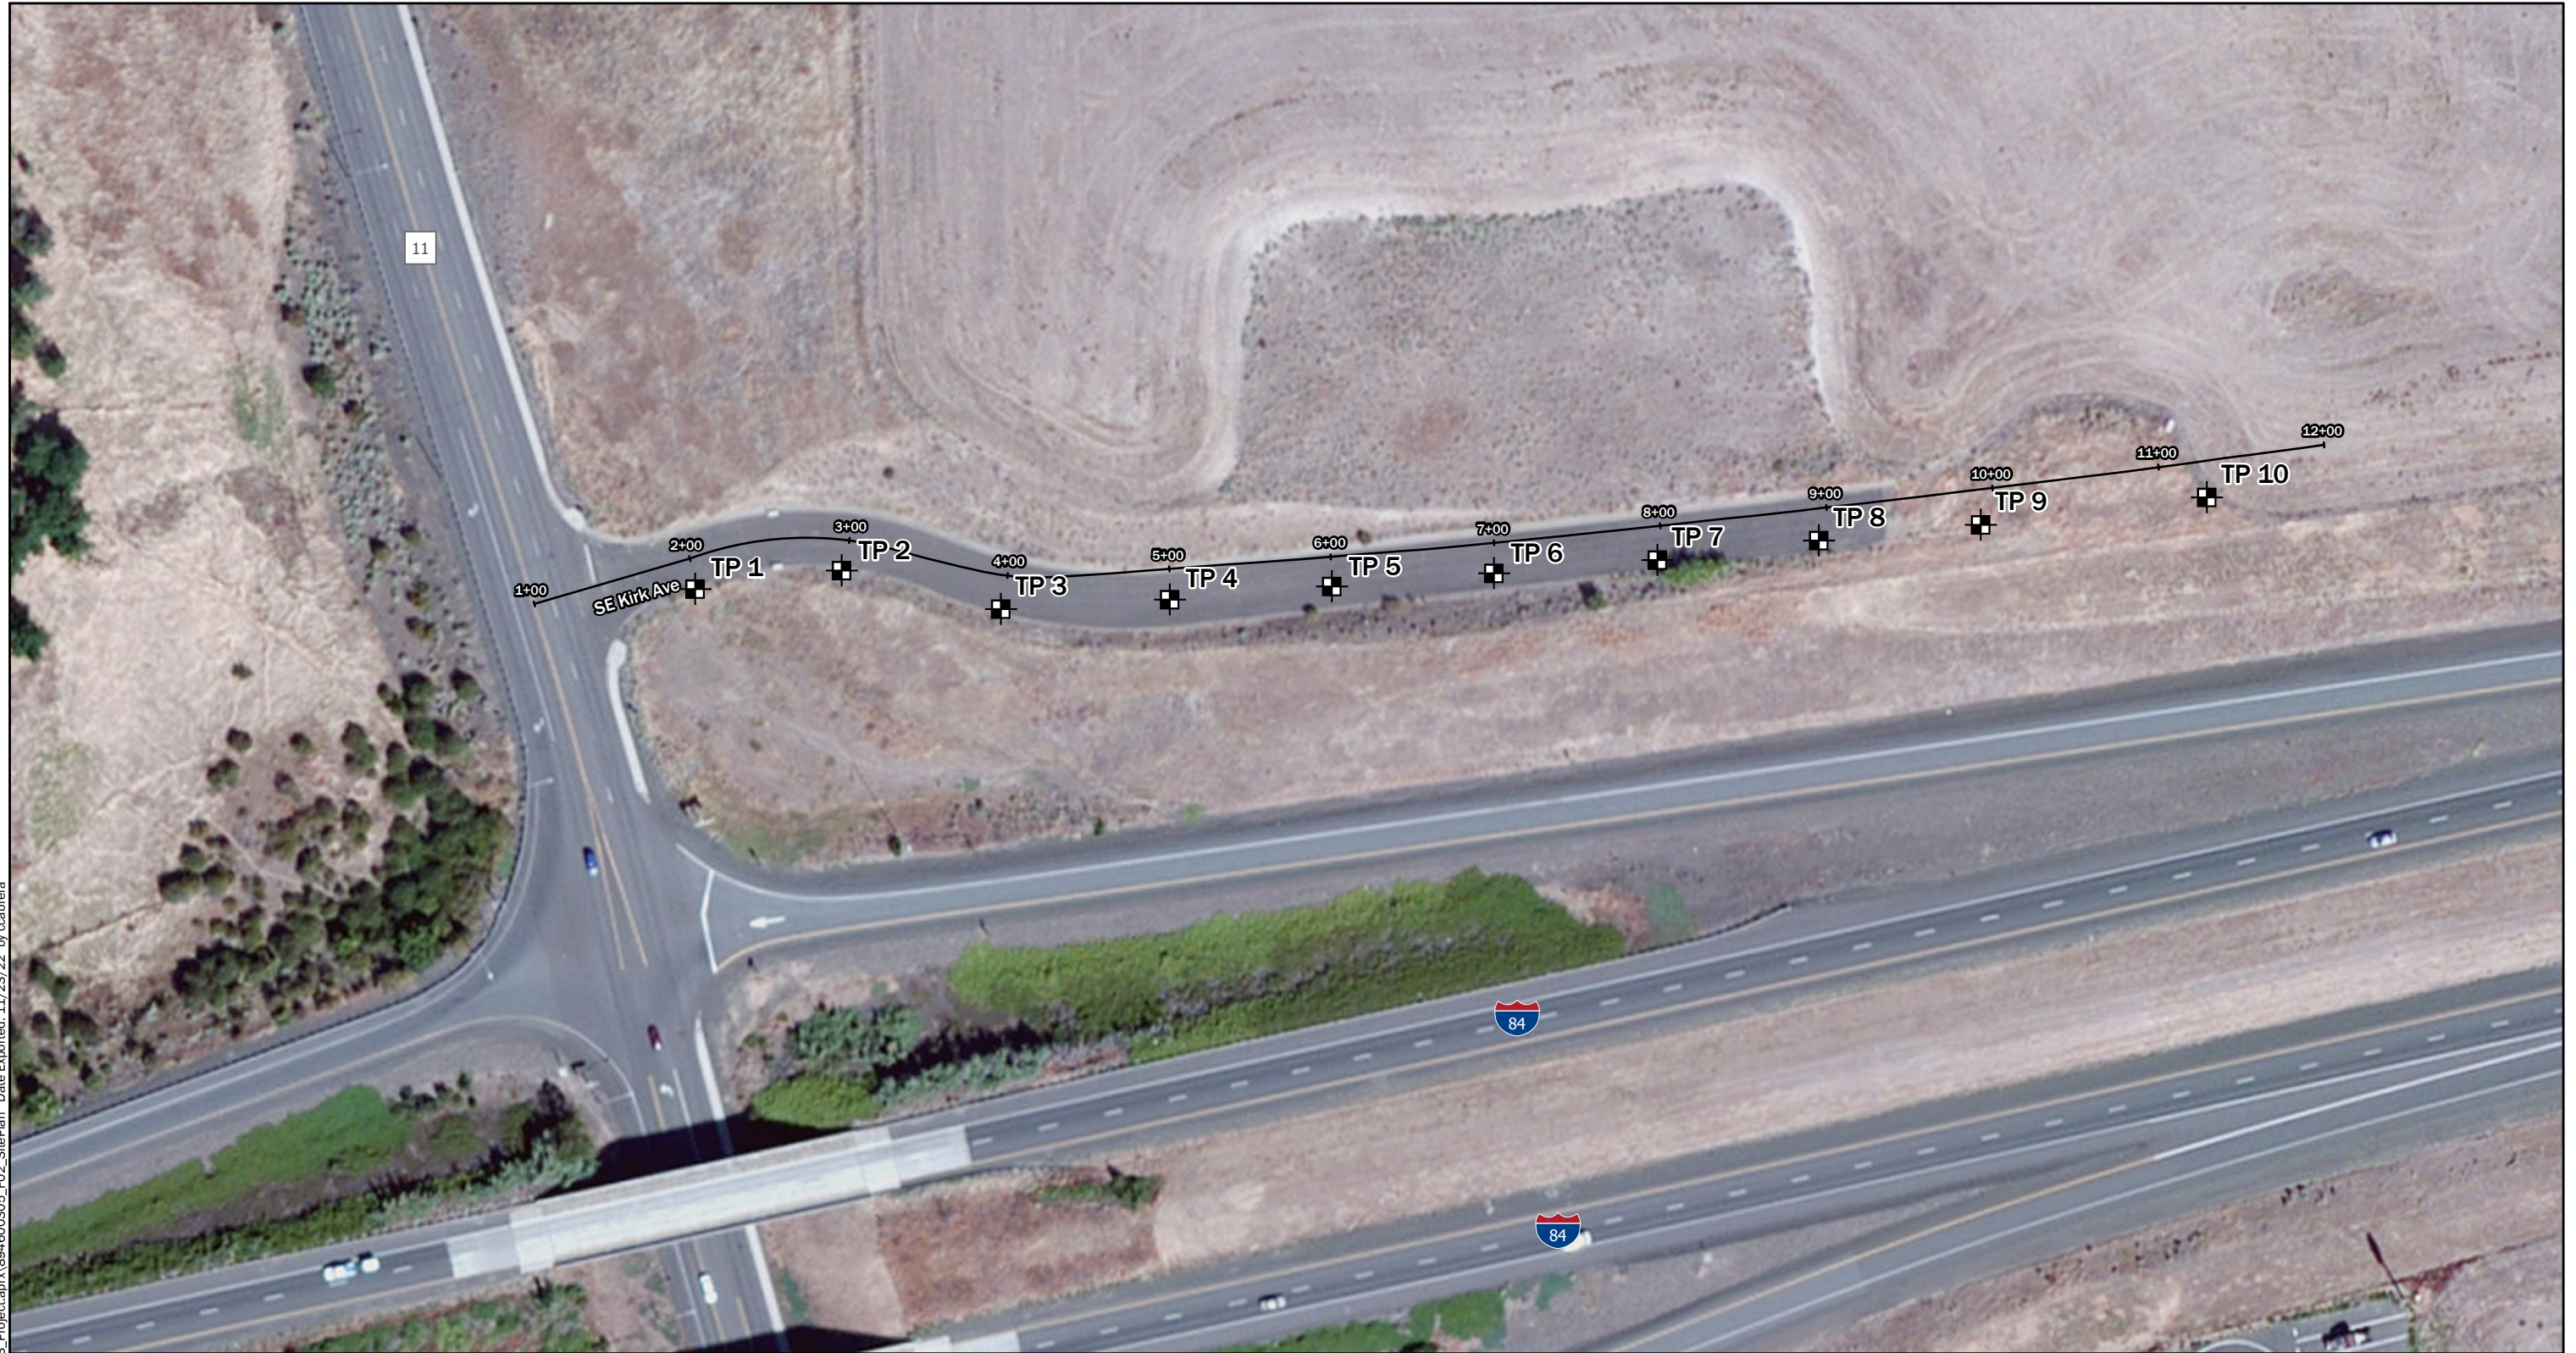
We explored subsurface conditions at the site on November 3, 2022 by excavating 10 test pits (TP-1 through TP-10). The test pits were excavated to depths in the range of about 4 to 10 feet below existing site grade using a rubber-tired backhoe owned and operated by the City of Pendleton. The approximate locations of our explorations are shown in the Site Plan, Figure 2.

We explored subsurface conditions at the site by observing the excavation of 10 test pits (TP-1 through TP-10) on November 3, 2022. Approximate exploration locations are shown in the Site Plan, Figure 2. The test pits were excavated to depths in the range of 4 feet to 10 feet below existing ground surface using a rubber-tired John Deere 310SK backhoe owned and operated by the City of Pendleton.

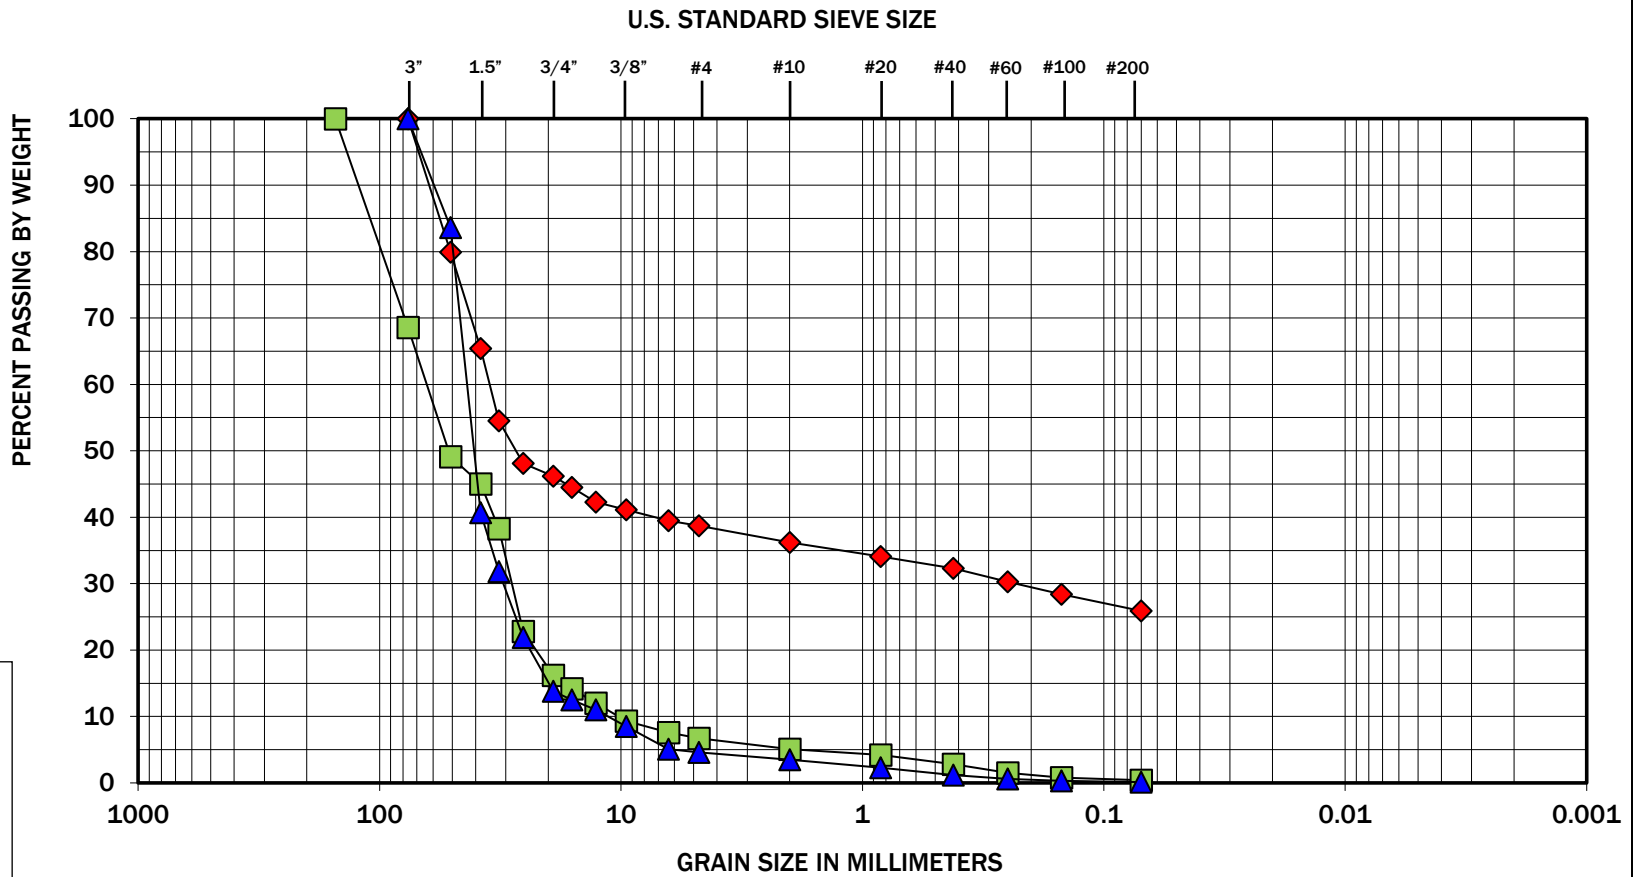
COBBLES	GRAVEL		SAND			SILT OR CLAY
	COARSE	FINE	COARSE	MEDIUM	FINE

Symbol	Boring Number	Depth (feet)	Moisture (%)	Soil Description
◆	TP-1	4 - 5	11	Silty coarse gravel
■	TP-4	2 - 3	7	Coarse gravel with silt and cobbles
▲	TP-5	5 - 6	7	Coarse gravel with trace silt
●

Standard Test Method for:	Test Method Designation	Total Tests Performed	Results Location
Atterberg Limits Determination	ASTM D 4318	3	Results presented in the applicable boring logs at the respective sample depths.
Grain Size Analyses	ASTM C 136	3	Presented in Figure A-12. Percent fines and moisture content also shown in boring logs at respective sample depths.
Determining the Amount of Material Finer than 75 µm (No. 200) Sieve in Soils by Washing	ASTM D 1140	5	Percent fines and moisture content presented in the borings logs at the respective sample depths.
